# Infrared For The Meter Shop

# How JCPB's Meter Shop Uses **Infrared** Scanning

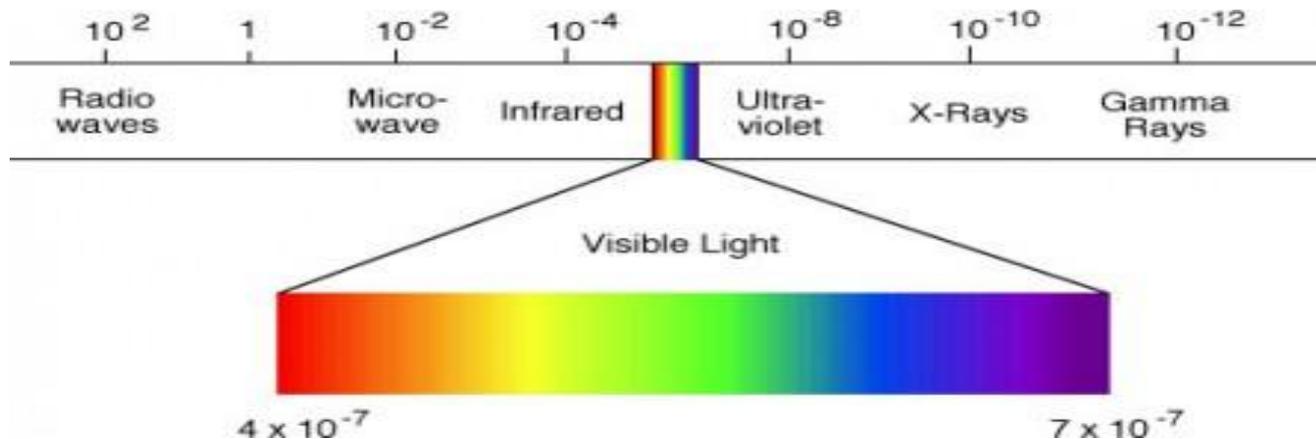
The human eye is sensitive to only a very narrow portion of the Electromagnetic Spectrum – visible light, the colors of the rainbow.

Infrared Radiation lies between the visible and microwave portions of the electromagnetic spectrum. Infrared Radiation cannot be seen with the human eye. Special equipment is necessary in order to be able to “see” Infrared Radiation.

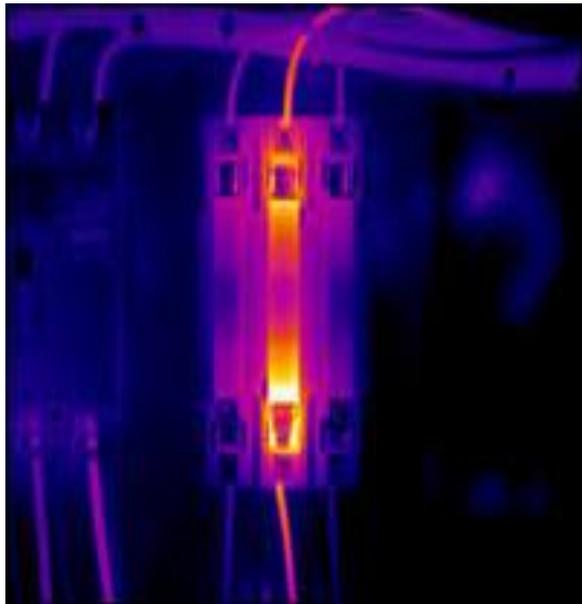
Heated Fuse

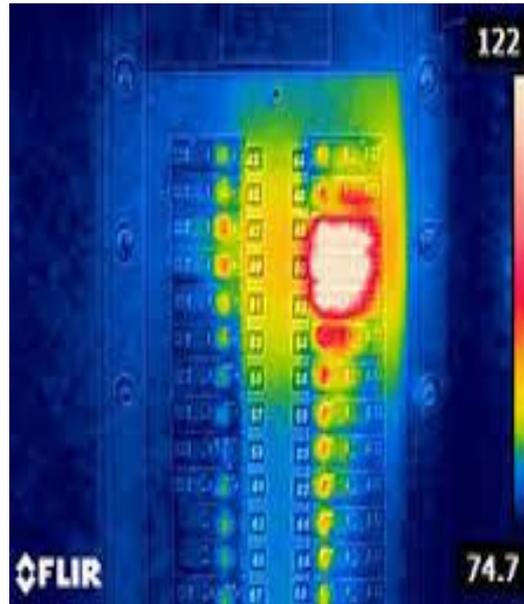
Overloaded Breaker

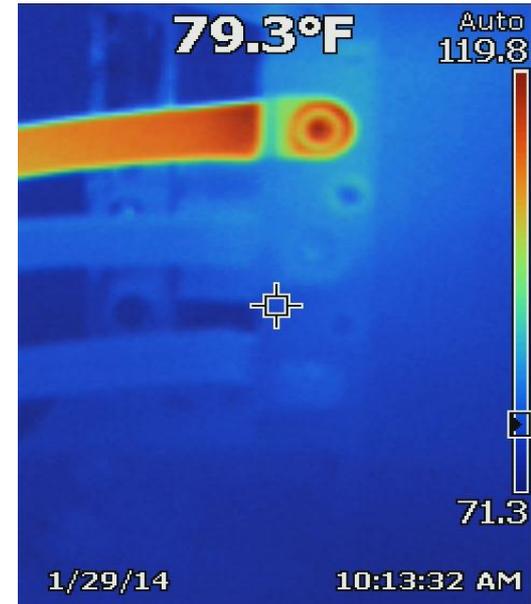
Loose Connection

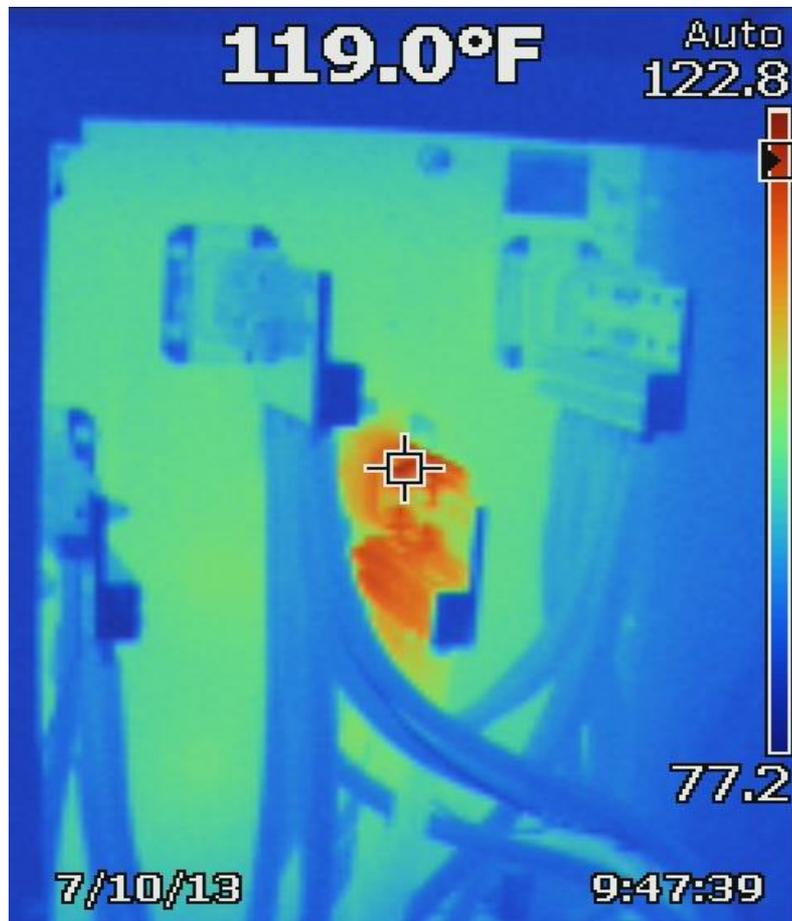
Loose Connection On 'B' Phase Spade

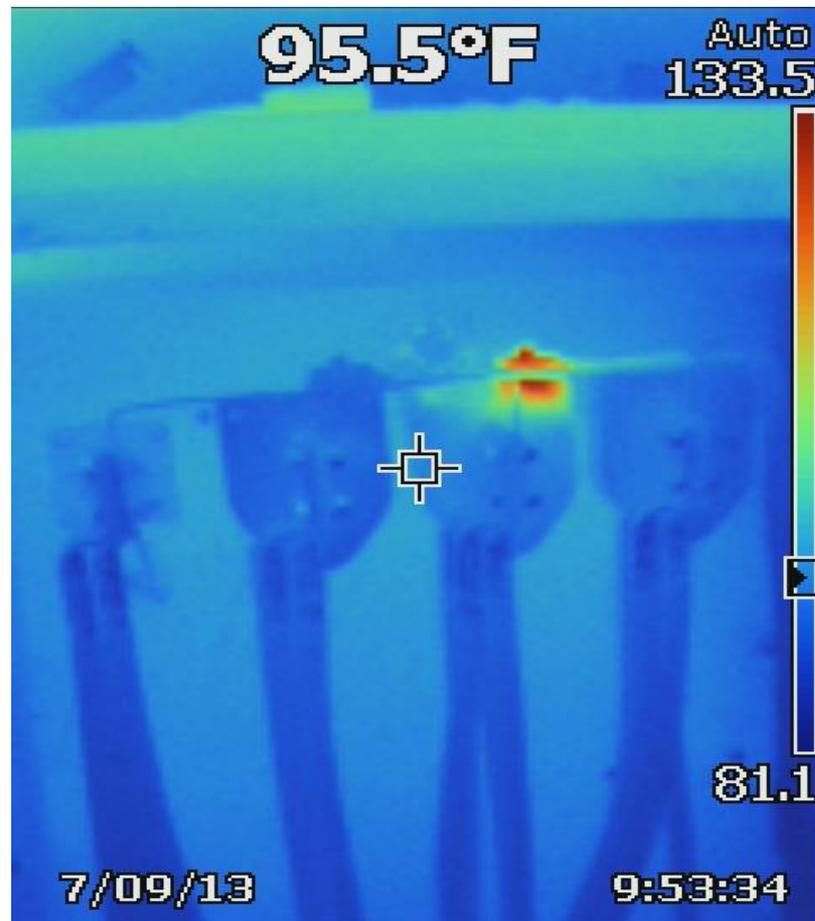
Loose Connection On 'B' Phase CT Terminals

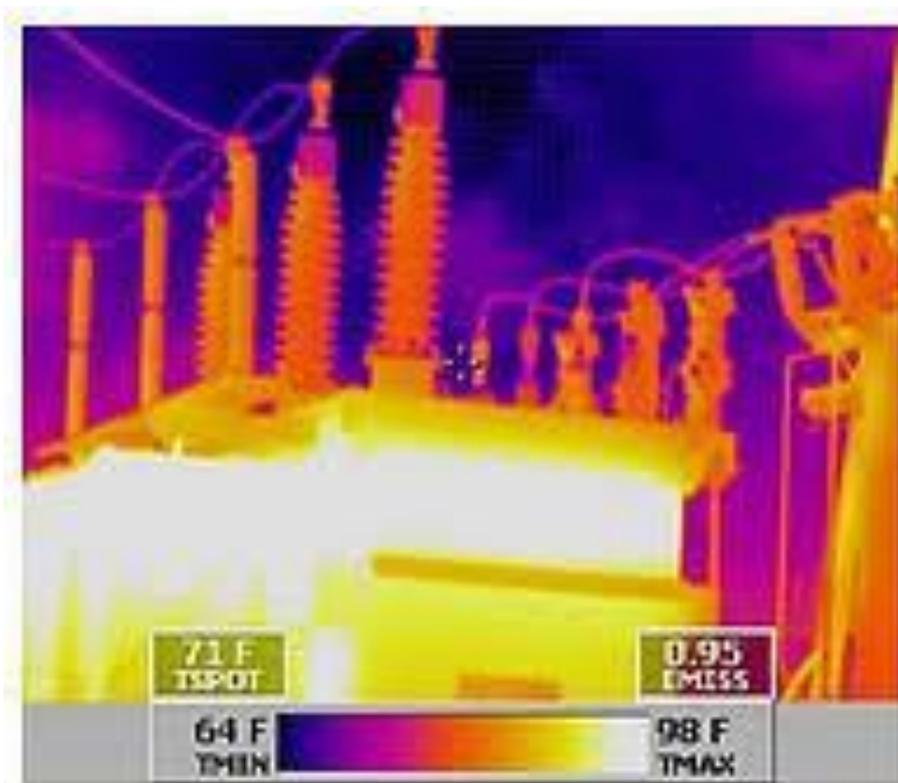
Load = Heat This Transformer Is Hot Because It Is Loaded Up

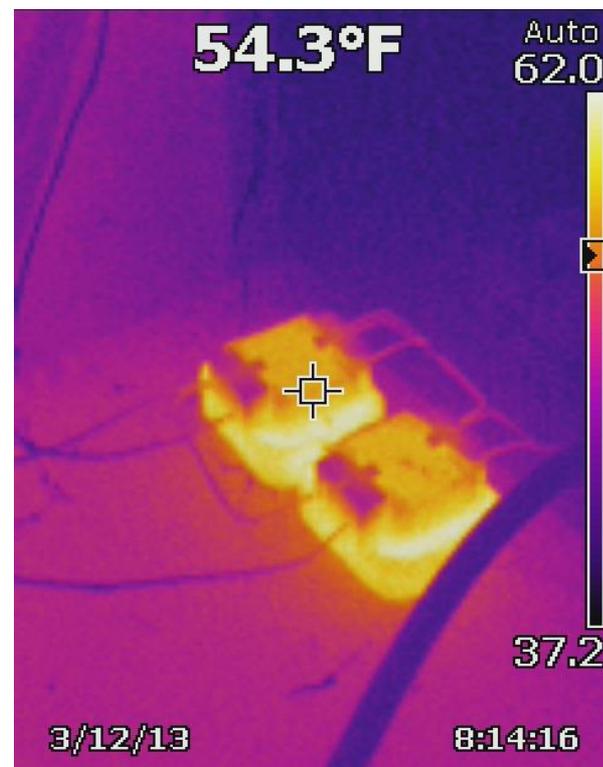
These PTs Are Hot Because They Are “HOT”

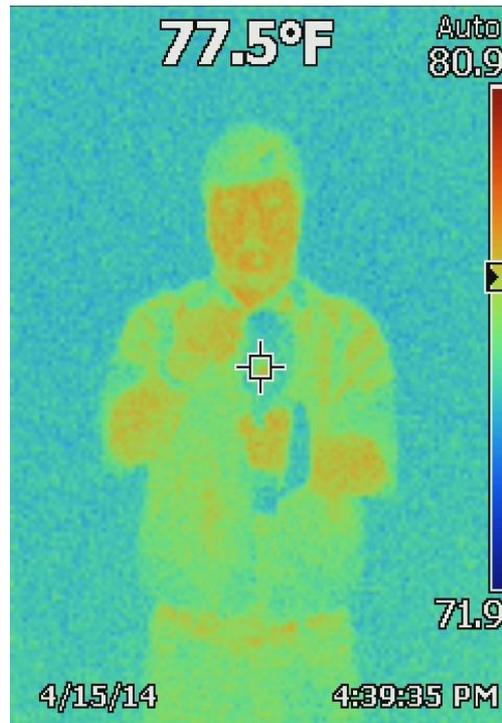
This is an image of my reflection in a mirror, taken in a completely dark room.

Infrared energy can be reflected similar to light. Make sure what you are seeing is a problem and not a false alarm caused by reflected heat.

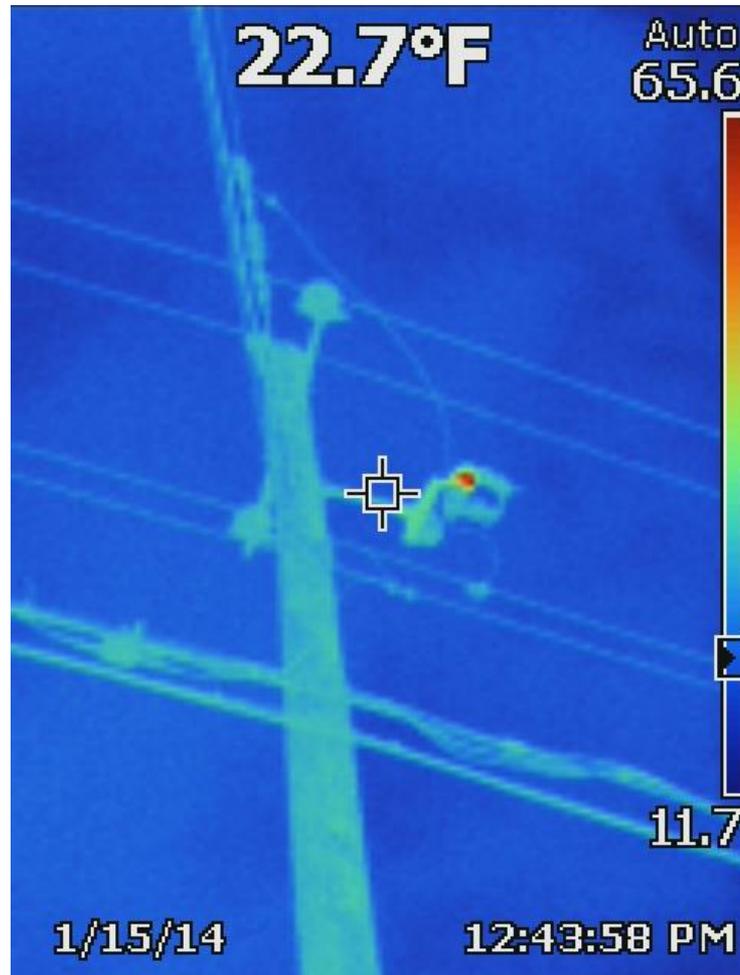
## Loose Connection On Cut-Out

Damage Cut-Out Was Replaced By Service Department **BEFORE** Any Customer Outage Occurred

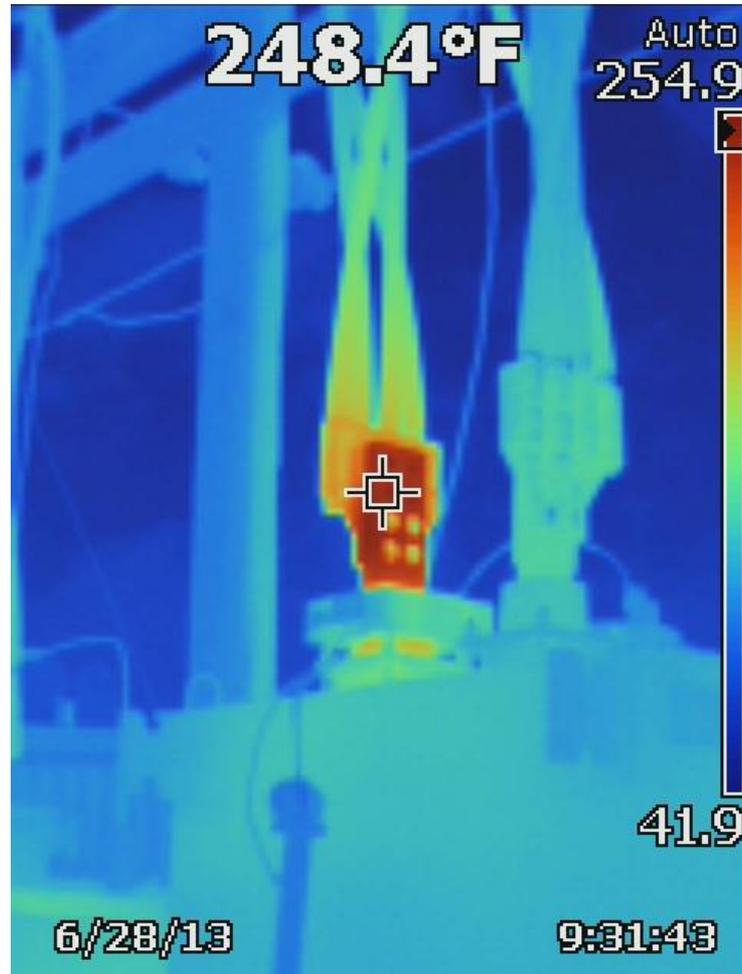
## Overheating Transformer Lug

Outage Was Coordinated With Industrial Customer And Transformer Was Repaired BEFORE Major Damage Occurred

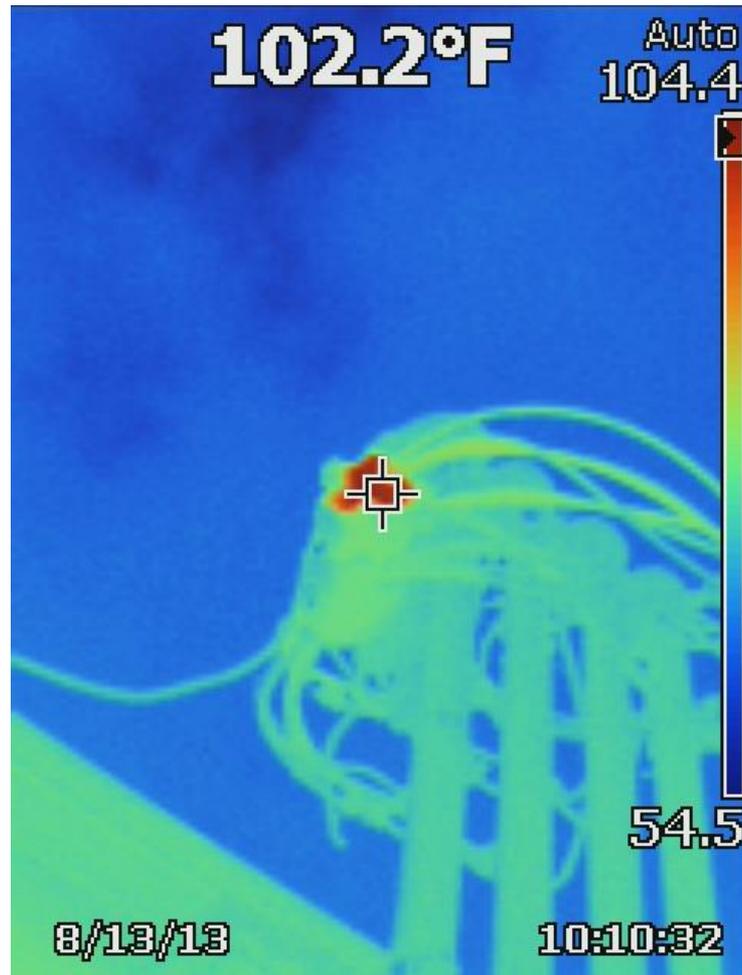
## Damaged Secondary CT

CTs Were Replaced On A Saturday While Customer Was Shut Down
